How to inspect your bmw M10, M20, and M30 camshaft core.

The purpose of this article is to outline what constitutes as an acceptable camshaft core. Our intent is to provide you with the best possible reground camshaft and in order to do that there are some simple criteria we need to have met. If your core does not meet the criteria below, please call us to discuss further options.

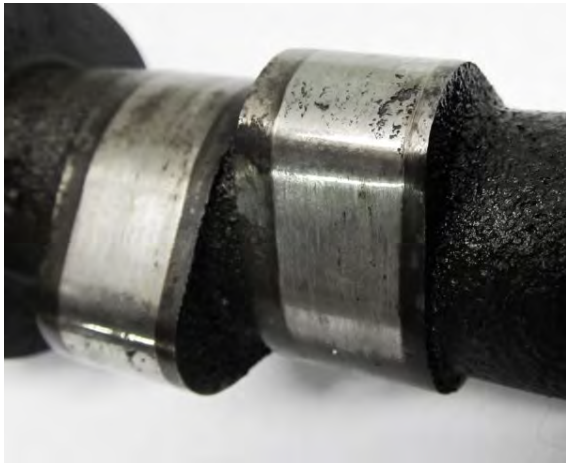
1) The individual lobes should be inspected for scoring or pockmarks. If you are able to run your fingernail across any given part of the lobe and encounter resistance then this cam should not be considered as a suitable core.

2) Check for any water damage, this might be visible as rust on the lobes or metal deterioration (if the water was allowed to sit on the cam for an extended period of time).

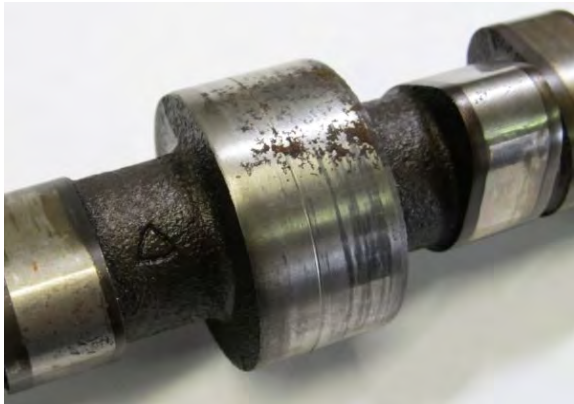
3) Just like checking the individual valve lobes, check the cam bearing journal lobes (larger circular lobes) for wear with your fingernail.

4) If you see that the nose of any of the individual lobes has been worn to where there is a shoulder on either side then this is not a good core.
